# The Cause of 100-year Low Carbonated Concrete of the Bridge

During the research study focused on 100 years, old concrete bridges in Slovakia an unexpected observation was made. Two bridges were found with a very low carbonation depth under an ordinary cement-based render coat used at the time of its construction for aesthetic reasons. The average measured value by phenolphthalein test was less than 2 mm after more than 100 years of service life in exposure class XC3 of EN 206. The remaining investigated bridges, from this period of construction, exposed to the same environment and made of concrete of comparable quality, showed significantly higher carbonation depths. Low carbonation depth, can be explained by the presence of a thin (2-4 mm) layer of the protective render coat (PRC) applied to concrete surface around 100 years ago. The place, where the PRC was of good quality was almost impermeable and the carbonation of the concrete underneath was even 0 mm. A narrow free space filled with the carbonates can cause increased non-permeability of the thin PRC creating thus the best condition for the built limestone-based (anti-carbonation) barrier with the ability to dramatically r

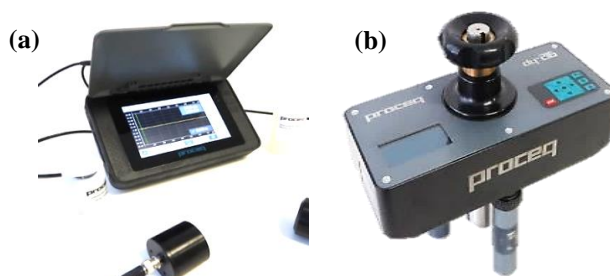
Fig. 1. Device for the on-site measurement of dynamic modulus of elasticity.

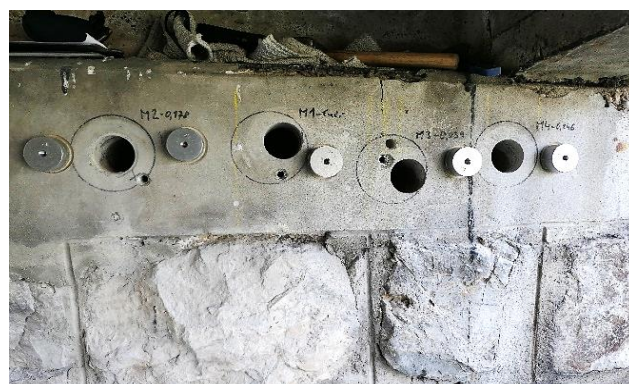
Fig. 2. Device for the on-site measurement of surface tensile strength.

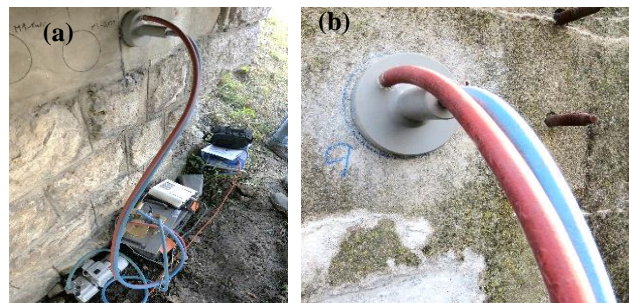
Fig. 3. Device for the on-site surface permeability measurement.

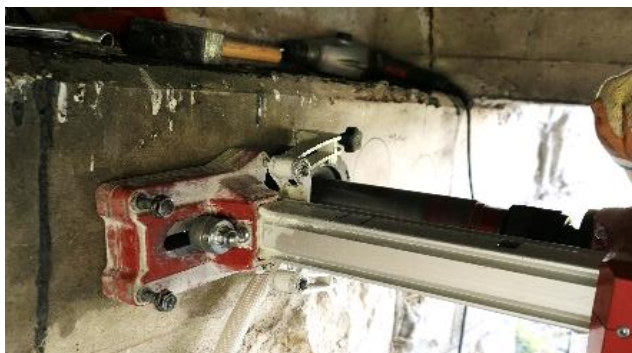
Fig. 4. Taking the cylindrical cores from a bridge.

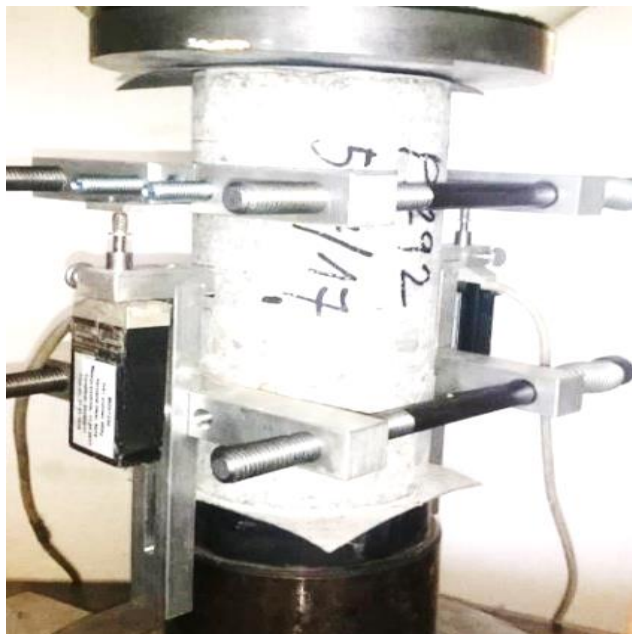
Fig. 5. Measurement of Young's modulus of elasticity.

In-situ tests applied in the current project concerned the following procedures: 1) testing concrete by hardness method using Schmidt hammer, model N according to STN 73 1373 [28], 2) ultrasonic examination of concrete by STN 73 1371 [29] using PUNDIT apparatus searching for the homogeneity of concrete material and hence the mechanical properties (Fig. 1a), 3) measurements of surface tensile strength of concrete using square breakaway targets according to STN EN 12 636 [30] (Fig. 1b and Fig. 2), 4) measurements of surface permeability of concrete and protective render coat (PRC) by Torrent air permeability test [31] for checking the surface permeability of uncovered and covered concrete by the PRC (Fig. 3a and Fig. 3b) and 5) carbonation depth by phenolphthalein test. The taken cylindrical cores with diameter 100 mm and length at least 300 mm were tested in the TSÚS laboratory (Fig. 4) for volume density (VD), dynamic modulus of elasticity (DME), Young's (static) modulus of elasticity (YME) [32] (Fig. 5) and compressive strength (CP) [33].

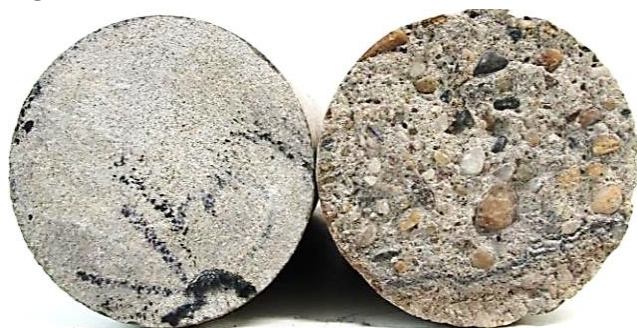
**Fig. 6.** Concrete from the bridge Sládkovičovo covered (left) and uncovered (right) by the PRC.

Four drilled cores were taken from the bridge Sládkovičovo (SL) in 2015. The attention was paid to the effect of the PRC with a focus on the relationship between the permeability and the efficiency of the PRC cover to prevent CO<sub>2</sub> ingress into the concrete beneath. The volume density, dynamic modulus of elasticity, Young's (static) modulus of elasticity and compressive strength of concrete uncovered by the PRC (SL-NON), given as a representative specimen with 100 years aggressive action of CO<sub>2</sub> are 2110 kg/m<sup>3</sup>, 30.8 GPa, 16.1 GPa, and 20.3 MPa. For comparison, the same data for surface-protected concrete by the PRC (SL-COV) with up to zero carbonation depth over 100 years are 2160 kg/m<sup>3</sup>, 35.9 GPa, 20.3 GPa, and 25.3 MPa. The depth of carbonation measured by phenolphthalein test was for the PRC SL-NON - around 60 mm, while that of SL-COV was even zero millimeters. The next range of experiments was conducted in 2018 with the far wider scope of on-site tests performed on the bridge, which were followed by laboratory tests using cylindrical cores (d = 100 mm, h = min. 300 mm). The composition of the old concrete, as well as the PRC, was not known; therefore, these data are not presented. **Fig. 6** shows two concrete specimens taken from the bridge: that on the left is the PRC-covered and on the right shows uncovered surface. The fragments of the PRC placed on the concrete surface are illustrated in **Fig. 7**.

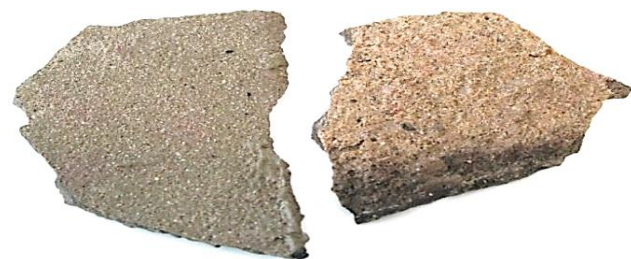
**Fig. 7.** Fragments of the PRC from outside (left) and inside view (right) of the concrete base.

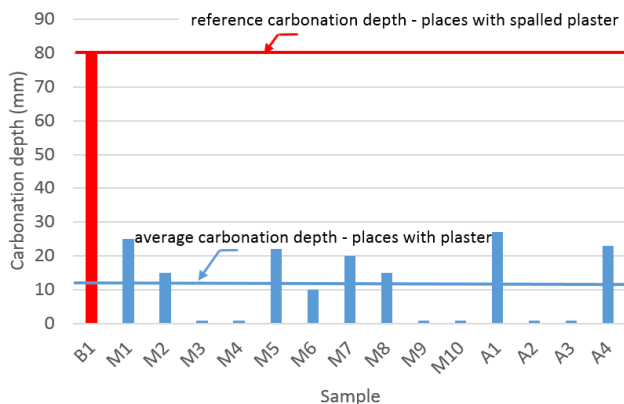
The low-permeable PRC ( $K = 0.073 \times 10^{-16} \text{ m}^2$ ) placed at the concrete surface acts as a protective barrier preventing  $\text{CO}_2$  diffusion over time. The results show that there are many carbonates collected in the tight space of the thin PRC layer. The high  $\text{CaCO}_3$  content implies that actual non-permeability is mainly due to the sequential deposition of carbonates in a PRC over time. This hypothesis is examined by the present research. However, one would assume high-material quality and technological discipline at placing the PRC as surface protection on the bridge concrete as well as no crack propagation and occurrence or any type of other mechanical damage of the PRC during the service life of concrete (bridge) structure. Today, the origin reason for PRC applying approximately 100 years ago is not clear but it has been just approved that this layer can act as an anti-carbonation barrier. It might be kept in mind that no chemical admixtures or additions, if any - only natural, were used at the manufacture of a concrete or PRC in such past time. It is stated that the observed low carbonation depth of underlying concrete can be explained by the protective effect of a thin PRC layer non-permeable for  $\text{CO}_2$ . The places, where the render coat was of good quality were found almost impermeable and the carbonation of concrete underneath was negligible (less than 2 mm, even 0 mm). Repeated measurements in 2018 confirmed the protecting function of the PRC. Even if the concrete was covered by a low-quality PRC it had much lower carbonation depth than concrete at places where the protective render coat spalled over time. **Fig. 8** shows the graphical evaluation of the results gained in 2015 (samples A1 to A4) and by the repeated tests in 2018 (M1 to M10) and B1 sample as the uncovered reference concrete. In any case the PRC, also if cracked or interface zone between concrete and PRC was disturbed, reduced the  $\text{CO}_2$  penetration into the underlying concrete. High-quality, impermeable PRCs showing no defects at the interface zone with the concrete (samples M3, M4, M9 and M10 of 2018 and A2, A3 of 2015) are characterized by very low, even zero carbonation depth, while the uncovered concrete without surface protection by a PRC even 80 mm carbonation depth.

**Fig. 8.** Carbonation depth of concrete below the protective render coat and on places where the PRC spalled.

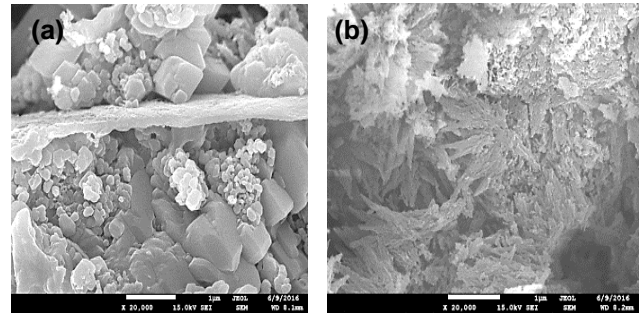
**Fig. 9.** Microstructure of uncovered 0-20 mm surface concrete SL-NON-1(a) and surface-protected concrete by the PRC (b).

The coefficients of permeability  $K$  related to M (3, 4, 9 and 10) samples are (0.039, 0.246, 0.189 and  $0.062 \times 10^{-16} \text{ m}^2$ ), while the B1 sample has extremely high, already immeasurable permeability. **Fig. 9a** and **Fig. 9b** illustrate differences between the microstructure of the unprotected concrete surface, and surface-protected by the PRC. Concrete with direct contact to air demonstrates the evident amount of the coarse crystallized carbonation products, while that protected by the PRC is densified by fine-grained carbonate alternates. The reduced content of coarse-grained  $\text{CaCO}_3$  in the original, 100 - year - old PRC can be attributed to a narrow space capable of its formation. When yet formed, the spatial deficiency of the PRC does not allow further  $\text{CO}_2$  penetration into the concrete beneath. The carbonation depth of the concrete specimen with the uncovered and covered surface is illustrated in **Fig. 10** to **Fig. 12**.

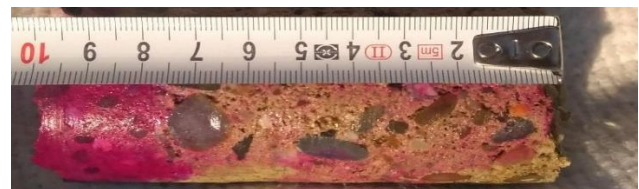
**Fig. 10.** Carbonation depth of concrete with the uncovered surface by the PRC.

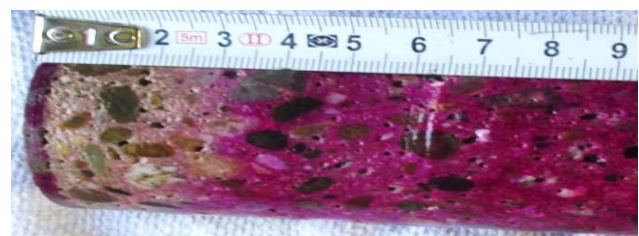
**Fig. 11.** Carbonation depth of concrete below the render coat characterized by the measured permeability of  $80.17 \times 10^{-16} \text{ m}^2$ .

The places, where the PRC was of good quality were almost impermeable and the carbonation of concrete beneath was negligible - less than 2 mm, even zero (see: **Fig. 12**). Concrete, at places covered with the PRC of higher permeability, had a greater carbonation depth (see: **Fig. 11**) but it was still significantly less than the carbonation depth at the places, where the PRC spalled (see: **Fig. 10**). The extremely low permeability of the PRC was partially explained by chemical analysis and electron microscope analysis. The results of these analyses were published in 2018 by the authors of this article [35] and could be summarized as follows:

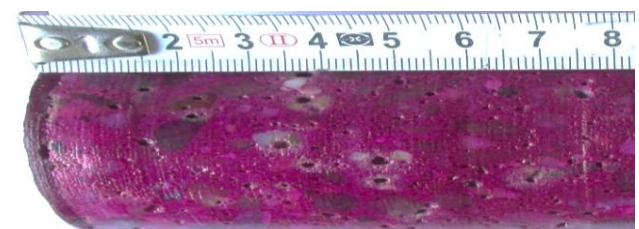
**Fig. 12.** Carbonation depth of concrete below the render coat characterized by the measured permeability of  $0.073 \times 10^{-16} \text{ m}^2$ .

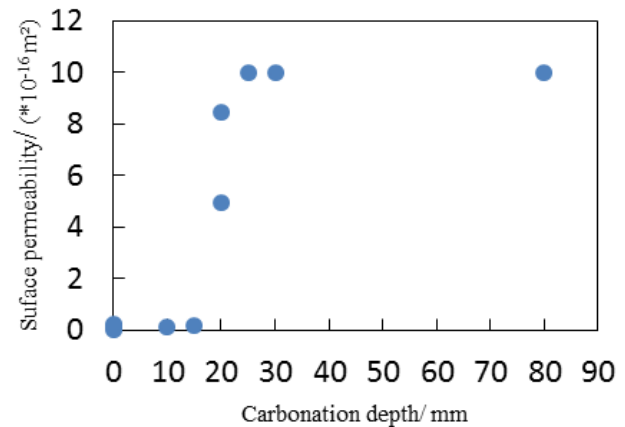
**Fig. 13.** Dependence between the coefficient of air permeability (surface permeability) and carbonation depth.

The dependence (**Table 3**) of decisive significance was found between the surface permeability of the PRC and the carbonation depth of the underlying concrete (**Fig. 13**); the PRC thickness indicates only a minor significance factor (**Fig. 14**). The PRC impermeability for CO<sub>2</sub> penetration is a basic condition for the apparent mitigating and even complete stopping carbonation attack of underlying concrete. The thin PRC layer is characterized by a dense carbonate substance even up to the amorphous state boundary, which is referred to as “carbonate milk” (a designation that has not been used yet). Images from the optical microscope at various magnifications show invisibly but later demonstrably accumulated carbonation milk within the thin PRC layer

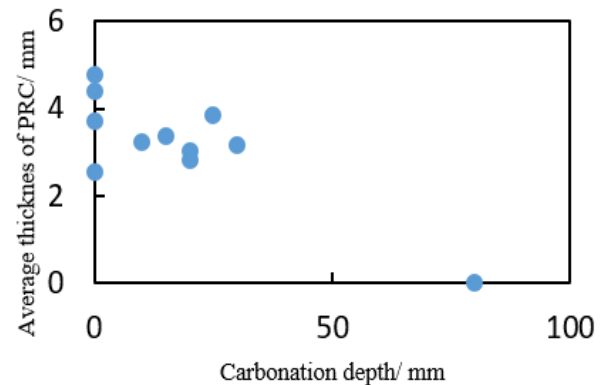
**Fig. 14.** Dependence between the average thickness of the PRC and depth of carbonation.

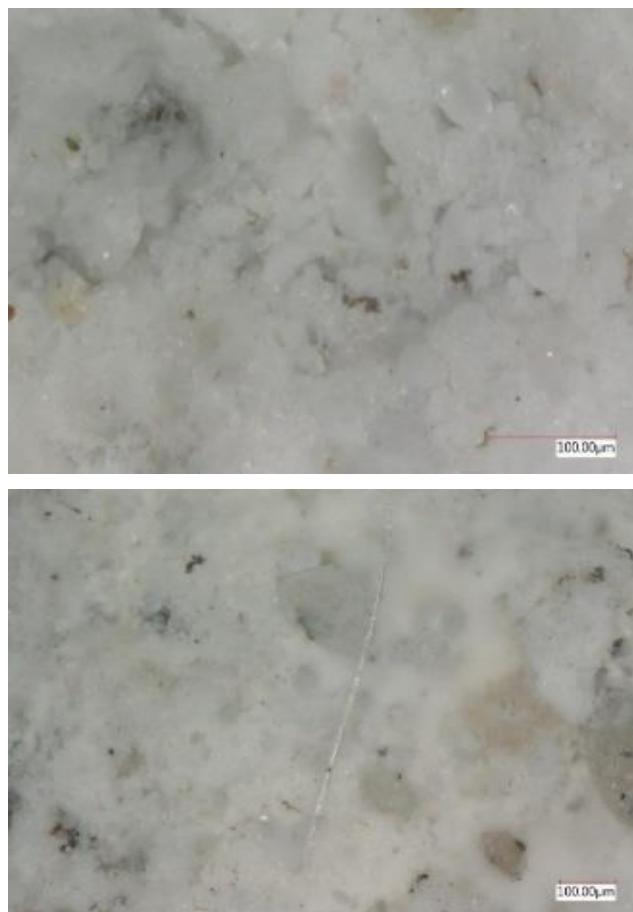
(Fig. 15). Shining needles confirm the presence of crystal-developed coarser  $\text{CaCO}_3$  compressed within the PRC thickness. The carbonate milk has such a low permeability with optimally functional PRC (M3, M4, M9, and M10 in Table 3) that the spatially sealed barrier of carbonation products is created in the PRC preventing thus carbonation of 100-year-old concrete effectively.

Fig. 15. Dense barrier created from the carbonation products in the space-tight conditions of 3.84 mm and 2.54 mm thin PRC M1.
