Structural performance of severely damaged reinforced concrete beams after SRP repair

Abstract

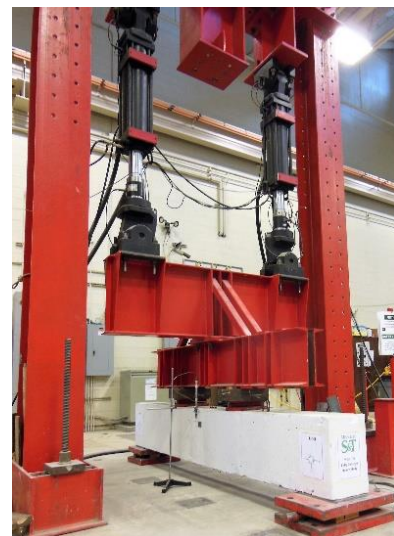
All the beams were simply supported and tested in a four-point bending configuration, as shown in **Fig. 1**. The load was applied by two 140 kips (620 kN) servo-hydraulic actuators. The actuators were intended to apply the two-point loads to the beams. The load was applied using a displacement rate of 0.050in./min (1.27 mm/min), and the automatic data acquisition system recorded data every second.

Fig. 1. Test setup.

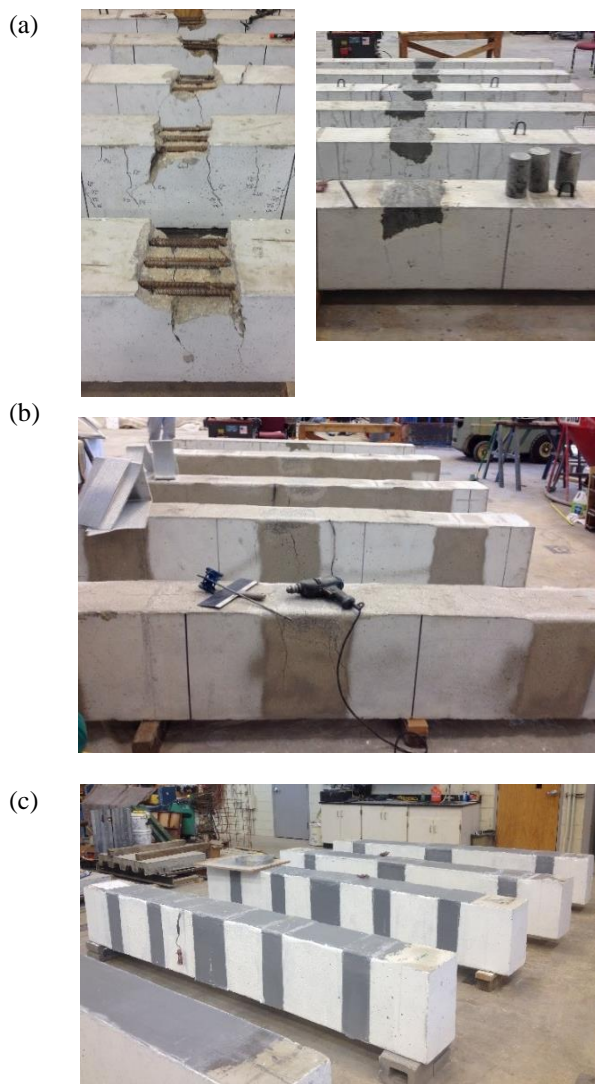
Prior repair and strengthening, the beams were tested to failure to simulate the condition of a damaged beam. Damaged area in the beams was repaired first by repairing damaged concrete before applying the SRP laminates to the concrete surface. The beams were placed upside down (i.e. rotated 180 degrees) where the beams' soffit could facilitate the repair work in the laboratory. The deteriorated and cracked concrete around and underneath the reinforcement was removed using a pneumatic hammer until sound concrete was reached. A wire brush was utilized to clean the rebar from any cementitious materials to provide a better bond with the new repairing materials. Higher pressure air jet was used to remove the dust and the loose particles from the surface. The surface area was then moistened prior to the placement of repairing concrete. High early strength concrete with a compressive strength of 6500 psi (45 MPa) at three days was used for repairing the damaged concrete which was removed. Prior to application of the SRP system, the concrete surface was sandblasted.

Fig. 2. (a) Repairing the damaged area, (b) Beams prior to external repair system application, (c) Application of the SRP system.

Concrete surface preparation was completed on the surfaces where the SRP laminates and U-wraps were applied. Sharp corners in locations of U-wrapping strips were rounded by 1.5 in. (38 mm) to reduce concentrated stresses at the edges of the corner locations. The application of the SRP laminate and the U-wraps followed the manufacture's specification. The repairing process of the beams is illustrated in **Fig. 2**.

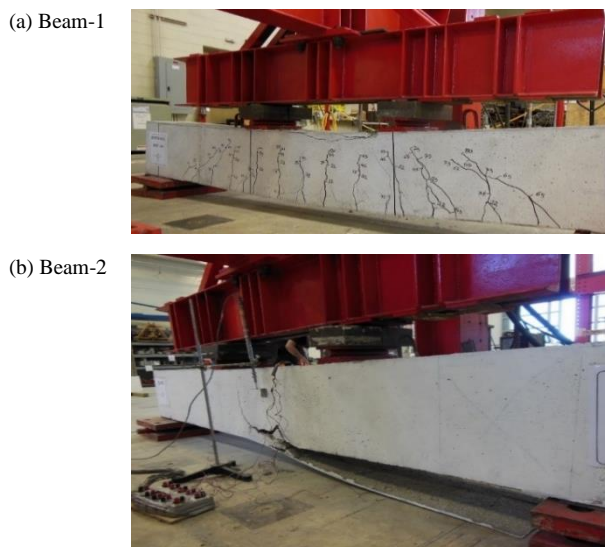
Fig. 3 represents the tested beams' images after reaching their peak failure. The control beam (beam-1) exhibited typical flexural cracks through testing. The flexural cracks started to propagate at the middle span and increased towards the ends. The cracks became wider as the applied loads increased. The failure mode was observed by yielding of the internal reinforcement followed by concrete crushing, as shown in **Fig. 3-a**.

The repaired beams experienced different modes of failure than the control beam. As the damaged beams were simulated by spliced internal reinforcement at the higher moment regions, no yielding of the internal reinforcement was exhibited. The retrofitted beams had a local failure at the maximum moment region. The failure of the repaired beam (beam-2) demonstrated by delamination of the repaired mortar and the SRP laminate, as shown in **Fig. 3-b**. Then, a debonding of the SRP laminate was exhibited at the peak load and extended toward the beam ends. All other repaired beams that retrofitted with the SRP laminates and the U-wraps had a debonding mode of failure. The debonding of the SRP system started at the midspan of the beams, as shown in **Fig. 3-c, 3-d, 3-e, and 3-f**. Then, the debonding of the longitudinal SRP laminates was extended through the beams' span. However, the two U-wraps located at each beam' ends did not observe any failure and were able to prevent the endplate debonding of the longitudinal SRP laminates. Increasing the U-wraps to five in the repaired beam (beam-5) with one-layer laminate was able to develop almost the full capacity of the SRP system. Therefore, a splitting and separation of the epoxy adhesive system was observed as the steel cords reached its high tensile strength in the U-wraps, as shown in **Fig. 3-e**.

Fig. 3. Crack patterns and mode of failures for all tested specimens.

3. The observed failure mode was influenced by the U-wraps. Delamination and debonding through the span length were observed for the repaired beam with the SRP laminate only. While a local debonding in the SRP system (SRP laminate and U-wraps) was exhibited in all other beams that repaired with SRP laminates and U-wraps.
