# Structural performance of severely damaged reinforced concrete beams after SRP repair

To experimentally examine the ability of the steel reinforced polymer (SRP) in restoring the moment capacity compromised by damage in the main steel reinforcement, six full-scale reinforced concrete (RC) beams were designed to simulate impact damage from over height vehicle collision. The simulation was represented by concrete beams reinforced with discontinuous reinforcement (splice in maximum moment region) and tested until failure due to splice. The damaged concrete was repaired, and the SRP system (longitudinal soffit laminates and transverse U-wraps) was applied to restore the original moment capacity. All beams were 10 ft (3.0 m) in length, 18 in. (457 mm) in depth, and 12 in. (305 mm) in width. Different repairing configurations were investigated. The studied variables were the provided laminate area and the amount and distribution of U-wraps. The ultimate load capacity, deflection, and mode of failure were recorded during testing. The test results were compared to beam results with continuous reinforcement. It was concluded that the repairing beams with the SRP system can restore the da

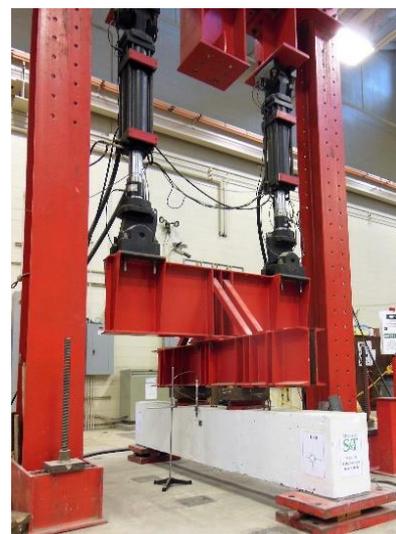
All the beams were simply supported and tested in a four-point bending configuration, as shown in **Fig. 1**. The load was applied by two 140 kips (620 kN) servo-hydraulic actuators. The actuators were intended to apply the two-point loads to the beams. The load was applied using a displacement rate of 0.050in./min (1.27 mm/min), and the automatic data acquisition system recorded data every second.

**Fig. 1.** Test setup.

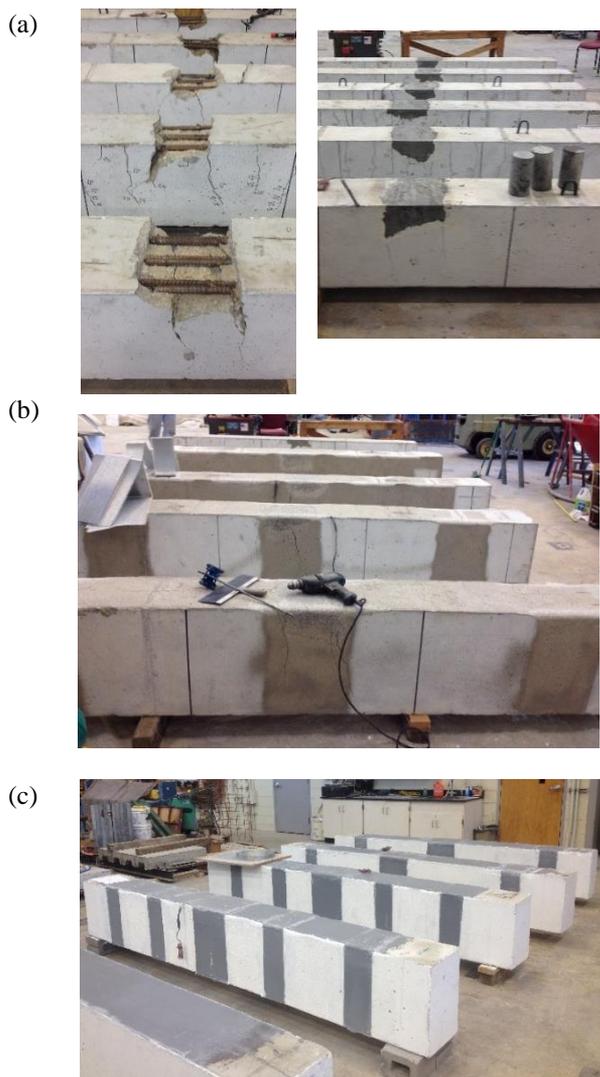
Fig. 2. (a) Repairing the damaged area, (b) Beams prior to external repair system application, (c) Application of the SRP system.

Prior repair and strengthening, the beams were tested to failure to simulate the condition of a damaged beam. Damaged area in the beams was repaired first by repairing damaged concrete before applying the SRP laminates to the concrete surface. The beams were placed upside down (i.e. rotated 180 degrees) where the beams' soffit could facilitate the repair work in the laboratory. The deteriorated and cracked concrete around and underneath the reinforcement was removed using a pneumatic hammer until sound concrete was reached. A wire brush was utilized to clean the rebar from any cementitious materials to provide a better bond with the new repairing materials. Higher pressure air jet was used to remove the dust and the loose particles from the surface. The surface area was then moistened prior to the placement of repairing concrete. High early strength concrete with a compressive strength of 6500 psi (45 MPa) at three days was used for repairing the damaged concrete which was removed. Prior to application of the SRP system, the concrete surface was sandblasted.

Concrete surface preparation was completed on the surfaces where the SRP laminates and U-wraps were applied. Sharp corners in locations of U-wrapping strips were rounded by 1.5 in. (38 mm) to reduce concentrated stresses at the edges of the corner locations. The application of the SRP laminate and the U-wraps followed the manufacture's specification. The repairing process of the beams is illustrated in Fig. 2.

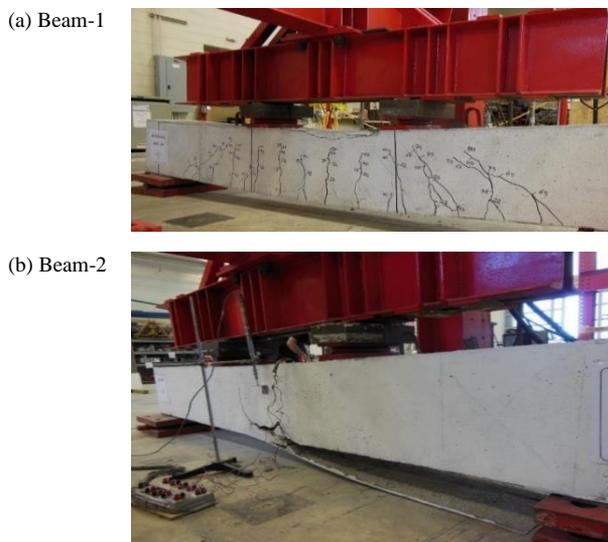
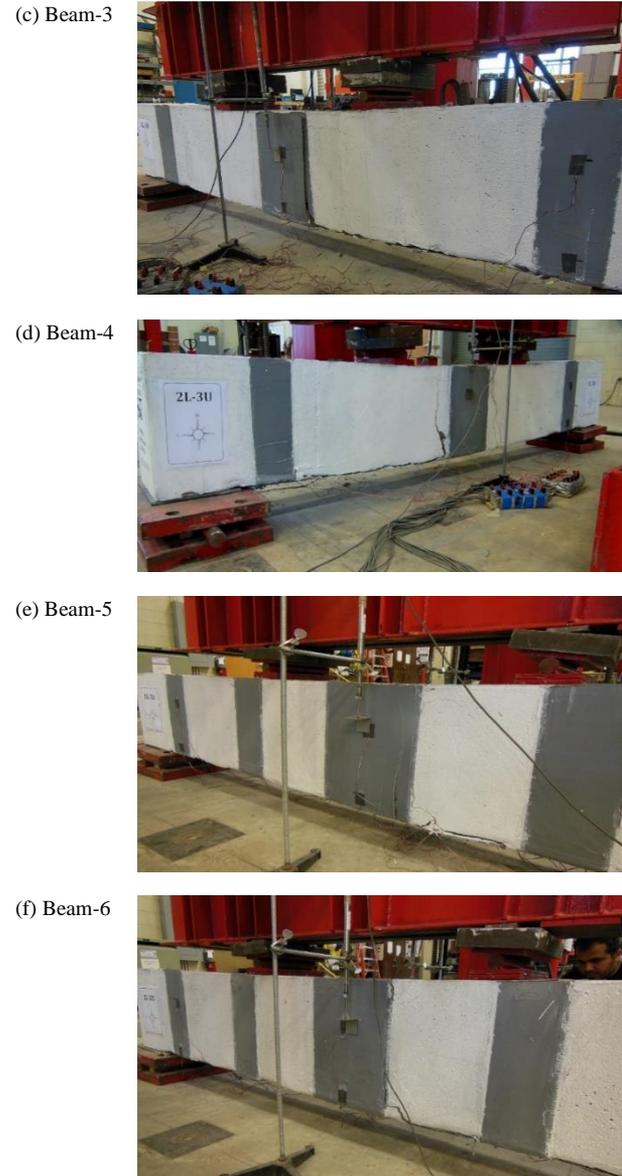
**Fig. 3** represents the tested beams' images after reaching their peak failure. The control beam (beam-1) exhibited typical flexural cracks through testing. The flexural cracks started to propagate at the middle span and increased towards the ends. The cracks became wider as the applied loads increased. The failure mode was observed by yielding of the internal reinforcement followed by concrete crushing, as shown in **Fig. 3-a**.

The repaired beams experienced different modes of failure than the control beam. As the damaged beams were simulated by spliced internal reinforcement at the higher moment regions, no yielding of the internal reinforcement was exhibited. The retrofitted beams had a local failure at the maximum moment region. The failure of the repaired beam (beam-2) demonstrated by delamination of the repaired mortar and the SRP laminate, as shown in **Fig. 3-b**. Then, a debonding of the SRP laminate was exhibited at the peak load and extended toward the beam ends. All other repaired beams that retrofitted with the SRP laminates and the U-wraps had a debonding mode of failure. The debonding of the SRP system started at the midspan of the beams, as shown in **Fig. 3-c, 3-d, 3-e, and 3-f**. Then, the debonding of the longitudinal SRP laminates was extended through the beams' span. However, the two U-wraps located at each beam' ends did not observe any failure and were able to prevent the endplate debonding of the longitudinal SRP laminates. Increasing the U-wraps to five in the repaired beam (beam-5) with one-layer laminate was able to develop almost the full capacity of the SRP system. Therefore, a splitting and separation of the epoxy adhesive system was observed as the steel cords reached its high tensile strength in the U-wraps, as shown in **Fig. 3-e**.

**Fig. 3.** Crack patterns and mode of failures for all tested specimens.

3. The observed failure mode was influenced by the U-wraps. Delamination and debonding through the span length were observed for the repaired beam with the SRP laminate only. While a local debonding in the SRP system (SRP laminate and U-wraps) was exhibited in all other beams that repaired with SRP laminates and U-wraps.

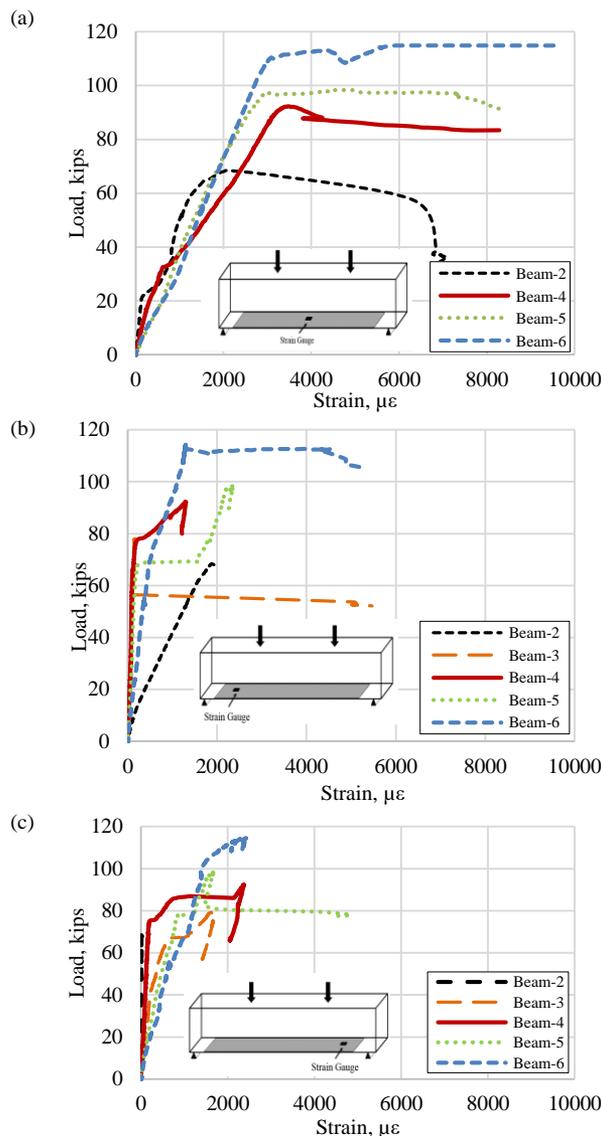
**Fig. 4** represents the strain readings of the SRP repaired system through the beams’ span at different locations. **Fig. 4-a** represents the strain reading of the SRP main laminates during the applied loads at the beams’ mid-span. In all beams (beam-2, beam-4, beam-5, and beam-6), the load-strain response in the SRP main laminates was similar. In the first stage, the strain was linearly increased as the load applied. The maximum recorded strain in the SRP laminate was observed when the beams reached their maximum peak load. Then, the strain reading continued to increase under the sustained load until the failure occurred. The strain reading was about 0.003 in./in. for the beams that repaired with the SRP laminates plus U-wraps. However, the strain reading was about 0.002 in./in. for the repaired beam without U-wraps.

The strain readings at the left side of SRP main laminates are illustrated in Fig. 4-b. The left side of SRP laminates exhibited less strain reading than that at the mid-span location. The higher recorded strain reading was at the peak loads. After that, no strain readings were recorded at the left side of SRP main laminate in beams (beam-2, beam-4, and beam-5) or the strain readings were continued the same as in beams (beam-3 and beam-

6). The strain readings at the right side were very conceded with the strain reading at the left side of all repaired beams. Also, higher strain readings were announced at the peak load (see **Fig. 4-c**).

**Fig. 4.** (a) Strain readings at midspan main layer of the repaired beam in addition to the undamaged beam (beam-1), (b) Strain readings at the left side of the main layer, (c) Strain readings at the right side of the main layer.

4. The highest strain reading in the SRP main laminate was recorded at the middle span of the repaired beams. The far right and left ends of the SRP main laminate had less strain reading.

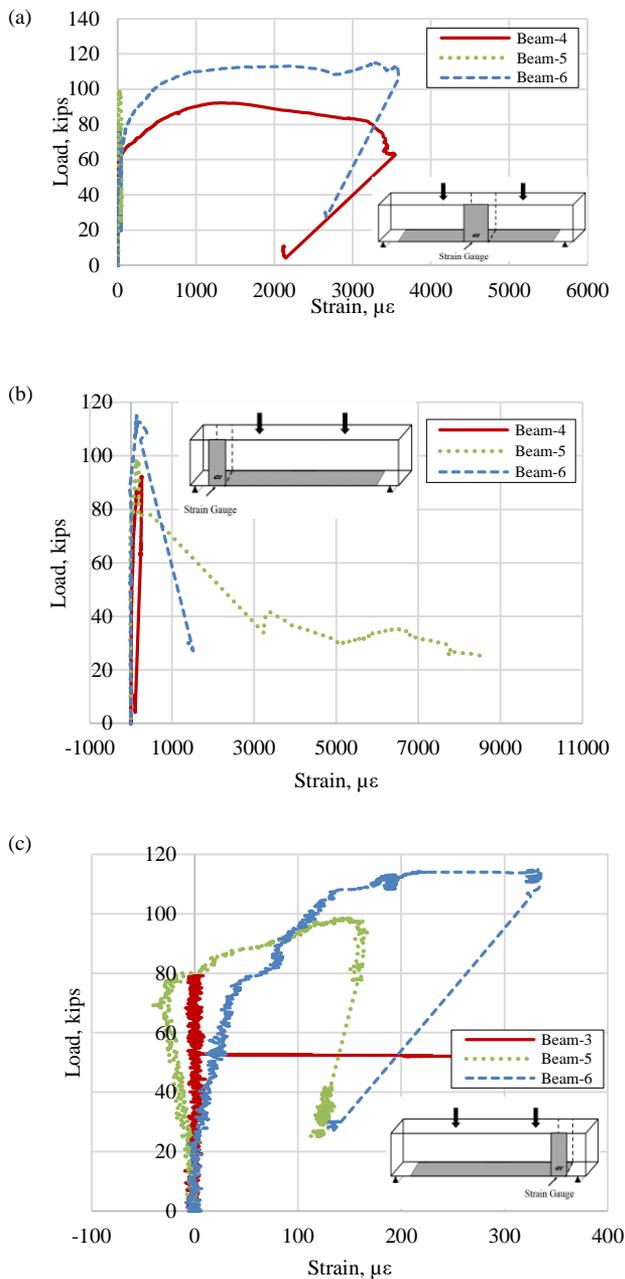
The strain readings for the U-wraps are shown in **Fig. 5**. For the midspan U-wrap (**Fig 5-a**), no recorded data for the beam-2 was obtained due to data acquisition error. In addition, the strain gauges for repaired beam-3 and beam-5 did not yield accurate strain readings with the applied loads. Strain gauges are sensitive devices and appeared unreliable beyond peak loading perhaps due to test damage. In spite of this, the load-strain response of the U-wraps is well represented for the repaired beam-4 and beam-6. The strain readings for these two beams remained near zero until the applied loads were very close to the peak load. This means that the U-wraps were not active engaged until a sufficient load was applied and the main SRP laminate started to lose its ability in

carrying more loads. Then, the strain readings continued to increase up to the peak load when a sudden drop in the strain readings was observed. The continuity of the strain readings at higher load level represented the confinement action of the U-wraps. The sudden drop in the strain reading represented the delamination or the debonding of the SRP laminate and the U-wraps.

**Figs. 5-b** and **5-c** represent the strain readings at the far ends (left and right) U-wraps. All of the U-wraps at the far ends did not exhibit effective strain readings at the peak loads because the failures of the repaired beams were represented by a local failure at the damaged area (mid-span location).

**Fig. 5.** (a) Strain reading at bottom midspan U-wrap, (b) Strain reading at the bottom left far end U-wrap, (c) Strain readings at bottom right far end U-wrap.

5. The middle span U-wraps in the repaired beams had the highest strain reading. While the far right/left side U-wraps exhibited almost zero strain reading at the peak loads. This illustrates the ability of the end U-wraps in preventing the endplate debonding failure mechanism.
