# The Resistance to UV Radiation for GFRP Pultruded Bridge Panels

Beata Stankiewicz\*

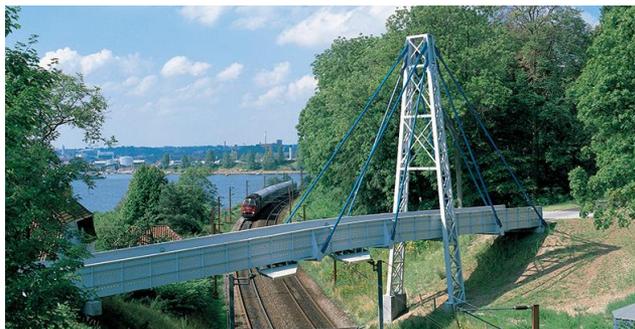
**Fig. 1.** All-GFRP Kolding Fiberline Footbridge, Denmark.

**Table 1.** Properties of GFRP Fiberline virgin composite of bridge panels in Kolding Footbridge in 1997.

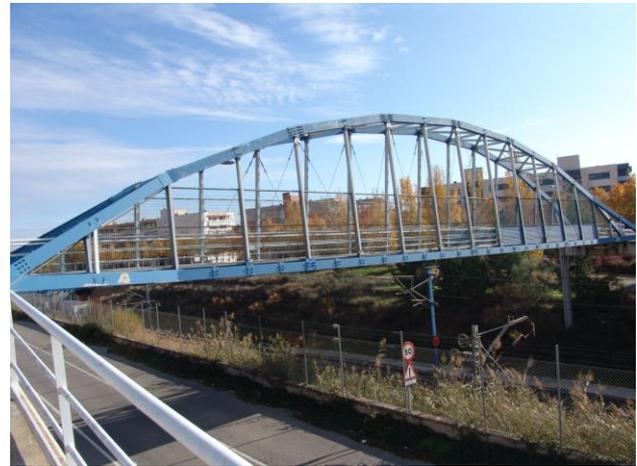
**Fig. 2.** All-GFRP arch Lleida Footbridge in Spain.

of the structure over decades. The perfect example of all-GFRP composite structure with protection of blue color coating of 60 µm is arch all-GFRP Lleida Footbridge in Spain, in Catalonia (Fig. 2).

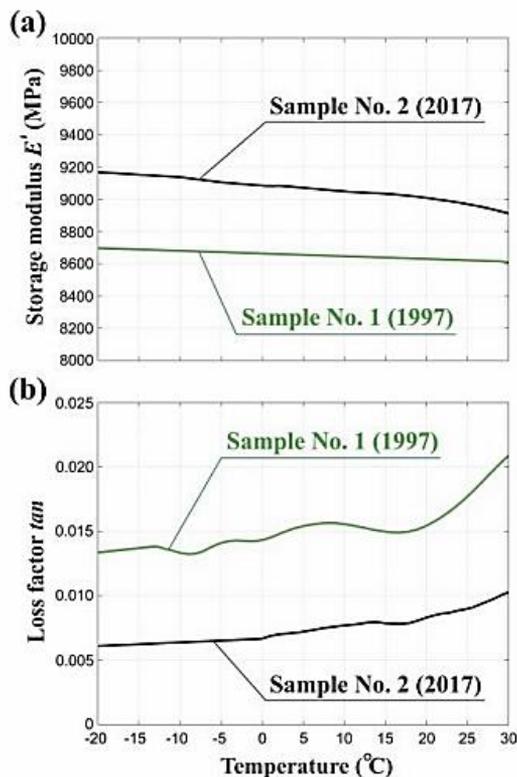
**Fig. 3.** DMA thermograms of Samples No. 1 (1997) and No. 2 (2017): (a) storage modulus  $E'$ ; and (b) loss factor  $\tan \delta$  as a function of temperature within real environmental temperature range.

the constant frequency of 5 Hz and at the heating rate of 2 K/min (the possible temperature range was from -40°C to +200°C) were applied. The values of storage modulus  $E'$ , loss modulus  $E''$  and loss factor  $\tan \delta = E''/E'$  were recorded as functions of temperature. Samples No. 1 (1997) and No. 2 (2017) as rectangular beams measuring 90×10×3.5 mm were inserted into clamps for sample fixation. Sample material was made of alternating layers of unidirectional E-glass fiber roving and strand mats embedded in polymer resin matrix. The influence of the temperature on the storage modulus of GFRP material, representing the elastic material behavior, was tested by DMA. The previous test was performed for both the intact material used in the Fiberline Bridge construction in 1997 and material acquired from the Fiberline Bridge after 20 years of natural aging. **Fig. 3** presents changes in  $E'$  and  $\tan \delta$  as functions of temperature determined for Samples No. 1 and No. 2 within the range of the natural environmental temperature from -20°C to +30°C. DMA has shown that both materials have similar thermomechanical properties what suggests an excellent thermal stability of composite material after 20 years of service life. It was found that the storage modulus of this material varies with almost linear relation from 9168 MPa to 8908 MPa within the range of the natural environmental temperature occurring in the bridge location conditions, i.e., from -20°C to 30°C. For example, the change of the temperature for 10°C causes the change of the storage modulus for about 0.5%.

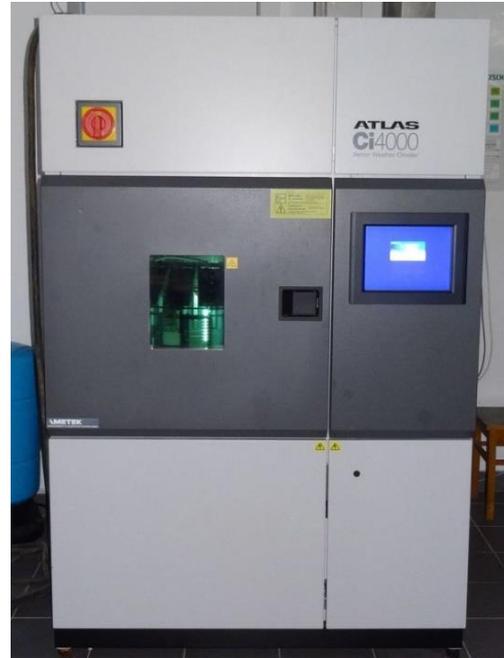
**Fig. 4.** Ci4000 Atlas Weather-Ometer®, equipped with a xenon lamp.

Ci4000 Weather-Ometer®, equipped with xenon lamp as the radiation source. The examination was carried out for 1893,3 h samples were subjected to irradiation of 388,8 MJ/m<sup>2</sup> (within scope of 300-400 nm) equivalent to a 1,5-year permanent UV exposure in the natural environment. SEM pictures from the cross section of examined samples, dusted with graphite, where achieved using an electronic comprehensive scanning microscope, during the first phase of research. Scanning Electron Microscopy was created by JEOL equipment with Energy Dispersive Spectroscopy decoder (EDS system). **Fig. 4** includes SEM images of the cross-sections of GFRP sample before laboratory UV exposure, but after synergistic effects of environmental impact in real outdoor condition, during 20 years of exploitation of bridge GFRP panel.

Testing the resistance of the supplied samples to the effects of weather conditions causing the so-called atmospheric aging was carried out in accordance with the PN-EN ISO 4898-2 standard in the aging chamber of the Ci4000 Weather-Ometer®, equipped with a xenon lamp being the source of radiation. Test method A1 with daylight filters was used. The test conditions are given in the **Table 2**.

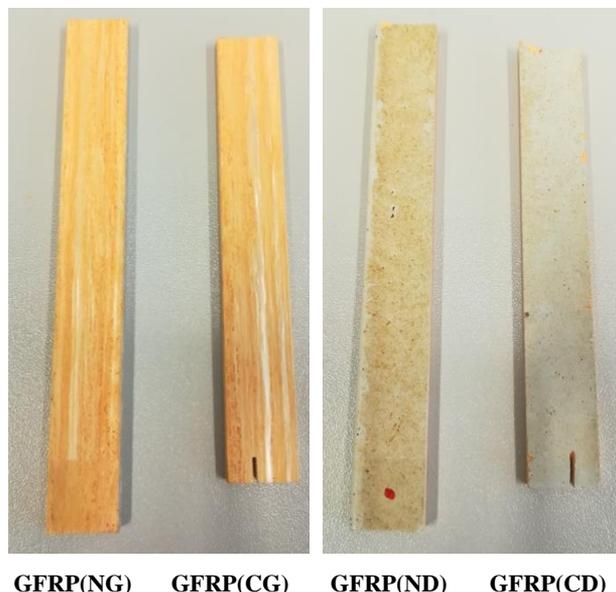
GFRP(NG) GFRP(CG) GFRP(ND) GFRP(CD)

**Fig. 5.** Aging GFRP 21,5 years old elements, using in morphology SEM test.

The objects of the research were two composite bars aged in Xenotest and presented in **Fig. 5**. Outside surface of two GFRP samples (ND) and (CD) and interior plane (NG) and (CG). The samples were after 21,5 years old of sun radiation, during the first period in natural environmental impact (20 years) and then during the second period in laboratory, based on Xenotest (simulated 1,5 year).

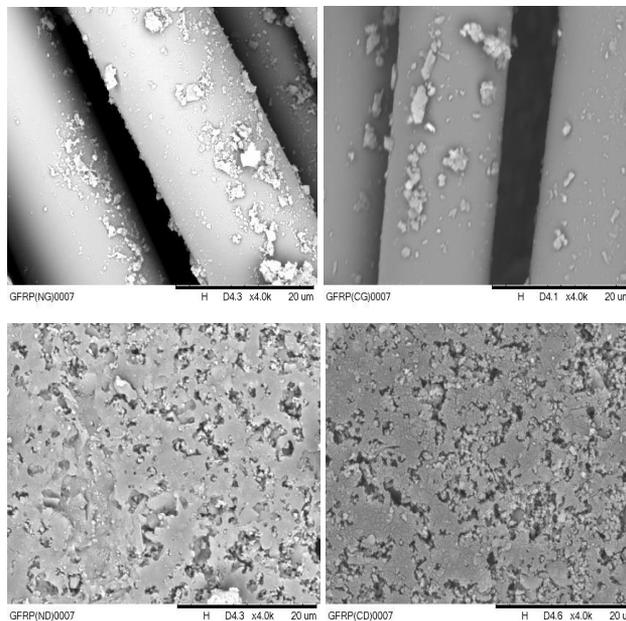
**Fig. 6.** SEM image of films no GFRP(CG), GFRP(CD), GFRP(NG), GFRP(ND) with magnification 4000x.

The subject of the research were also composite GFRP elements not aged in Xenotest and not aged in natural environment as a reference virgin material: GFRP(NN), GFRP(NNN), GFRP(NCW). Parameters of test morphology and kind of microscope observation: the name of the machine Hitachi TM3000 camera, type of EDS pickup, electron beam voltage 15 keV, sputtering Au/Pd, spraying time 180 s. Image analysis of the surface structure of films using the SEM method: 50x, 200x, 800x, 2000x, 4000x (**Fig. 6**) was prepared.
